UH-1 ACCIDENT SUMMARY

THE U.S. ARMY BOARD FOR AVIATION ACCIDENT RESEARCH - FORT RUCKER, ALABAMA

1 July 1966 through 30 June 1967

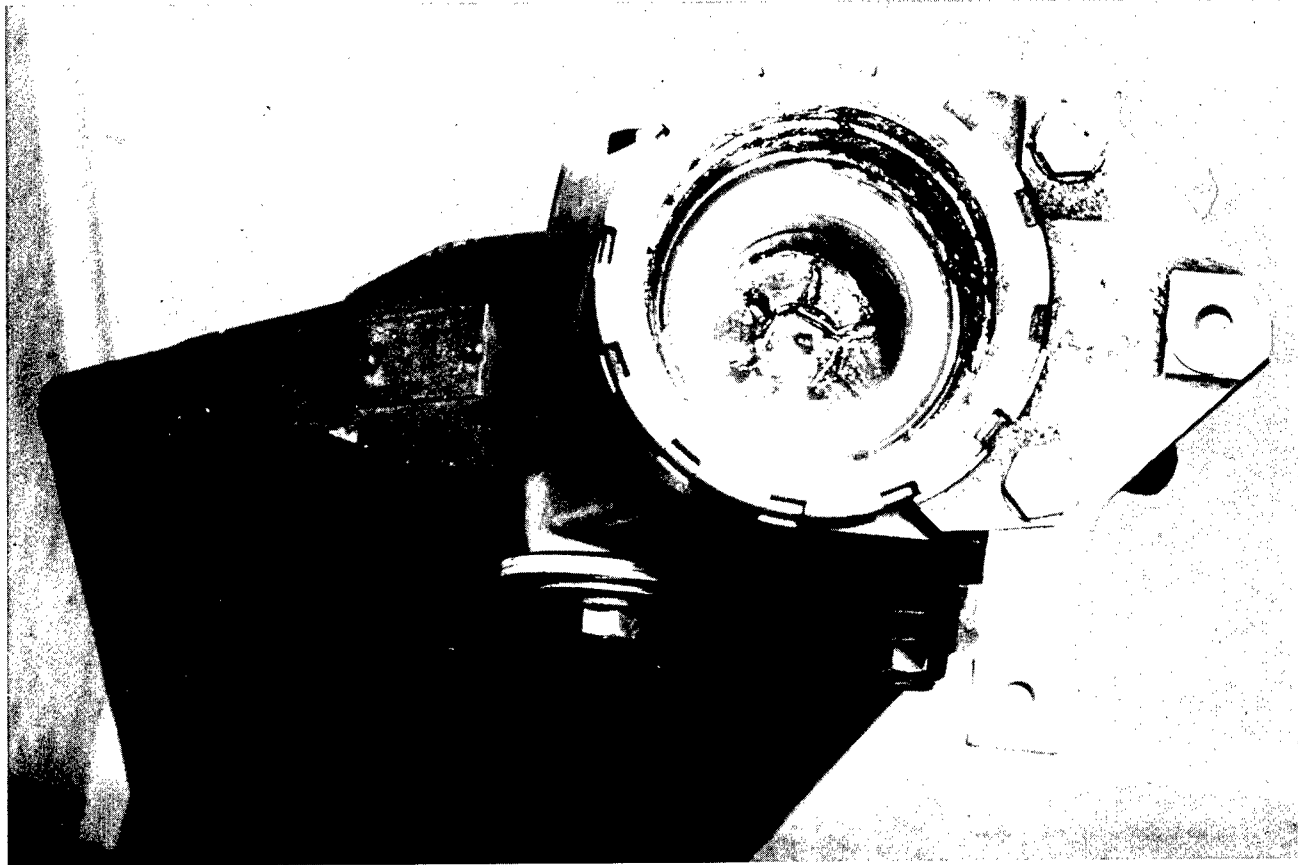
H813 - Tail rotor yoke failed because retaining nut was improperly torqued.

H813—Pilot heard loud explosive noise during hover to takeoff pad for maintenance test flight. Aircraft vibrated and turned to the right. Power was reduced and aircraft landed hard on left skid. Tail rotor and gearbox separated from pylon, and tail boom was severed by main rotor blade. Caused by failure of tail rotor yoke due to loss of retaining nut torque.

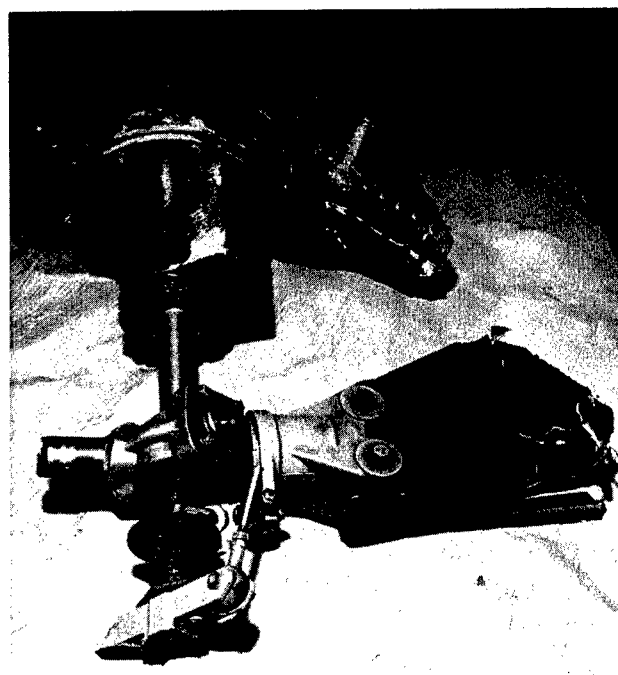
050512 - Severed threaded area of yoke arm caused by failure of tail rotor hub assembly.
